TECHNICAL SERVICE BULLETIN

Water Leaking On Right Front Floor During Or After A/C Use - Built On Or After 31-Aug-2018

19-2345
18 November 2019

Ford
2018-2020 Expedition
2018-2020 F-150
2018-2020 F-Super Duty
Lincoln
2018-2020 Navigator

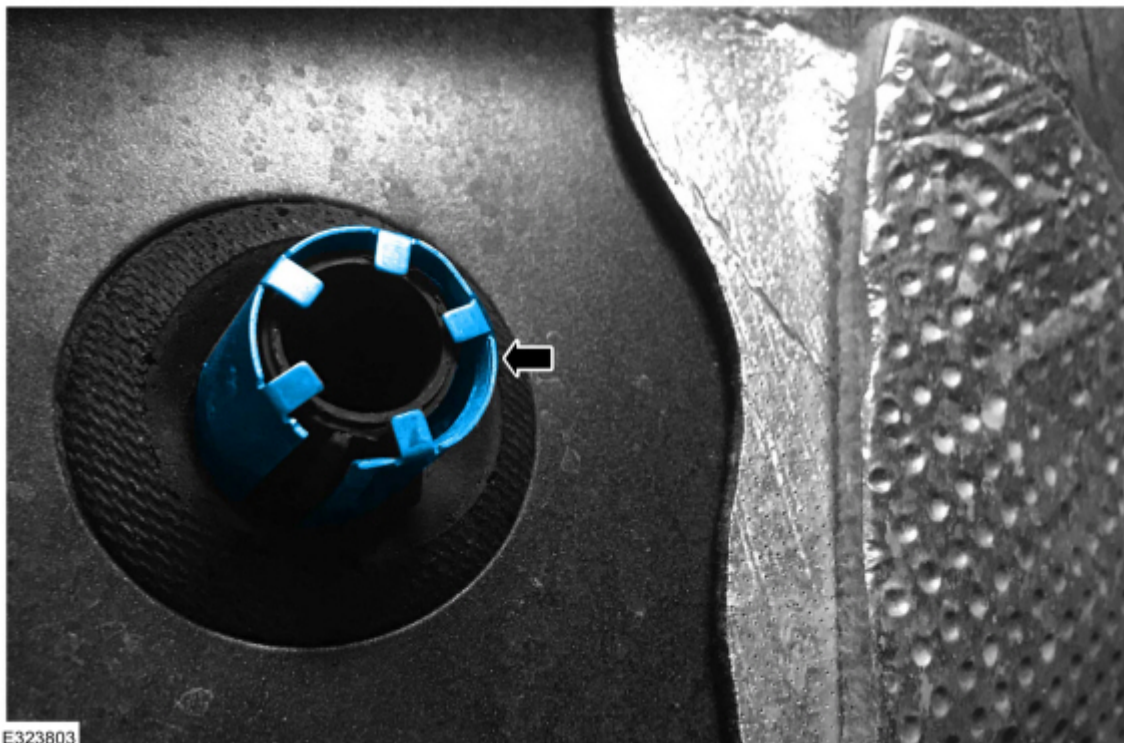
1. Raise the vehicle and remove the right front tire.
2. Remove the right front fender splash shield. Refer to the Workshop Manual (WSM), Section 501-02.
3. Using needle nose pliers or equivalent, remove and discard the metal shield from the evaporator drain tube by bending the tabs away from the tube. (Figures 1-3)

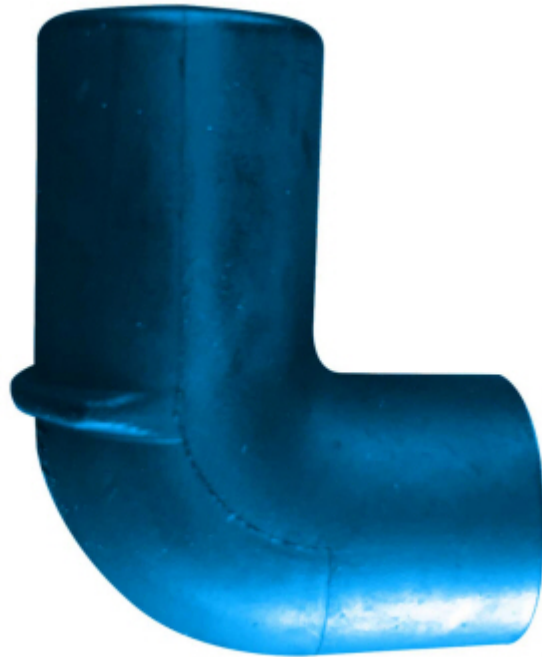
4. Lubricate the inside of the elbow with water. Install the short end of the elbow onto the drain tube. (Figures 4-5)
